Contract #: 04-0120F4Cty: SF/ALA Rte: 80 PM: 13.2/13.9File #: 1.28**WELDING INSPECTION REPORT**

**Report No:** WIR-029728  
**Date Inspected:** 22-Jun-2013

**Project Name:** SAS Superstructure  
**Prime Contractor:** American Bridge/Fluor Enterprises, a JV  
**Contractor:** American Bridge/Fluor Enterprises, a JV

**Bridge No:** 34-0006**Component:** SAS Tower**Summary of Items Observed:**

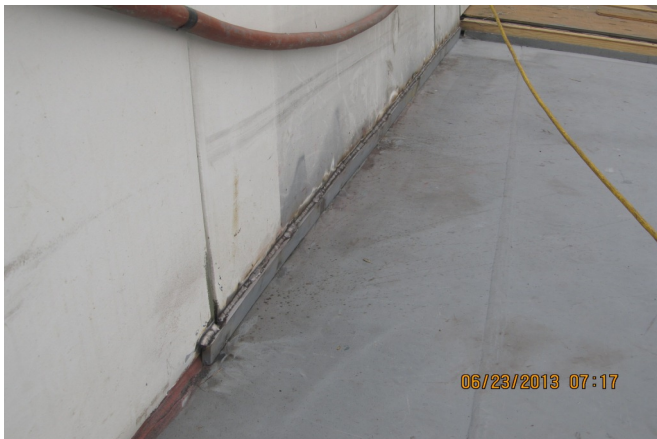
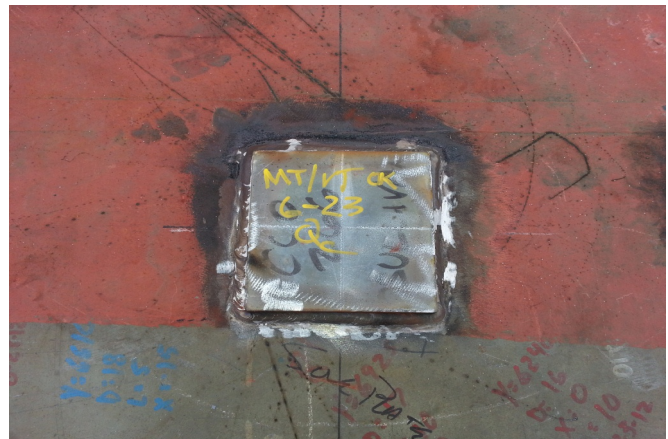
This QA Inspector randomly observed ABF welder Eric Sparks #3040 perform Shielded Metal Arc Welding (SMAW) on bar stock utilized as shim plates to the bottom of the barricades at Hinge A on the north and south sides of the west bound OBG. The bar stock is to cover the gap left at the bottom of the barricades to the deck surface. The welder was observed placing a 3mm fillet weld the length of the bar and 6mm fillets 2" long every 6 Inches. Quality Control was present and the work had been conducted without approved details from Engineering. This QA Inspector will generate a TL-15 on 06/23/2013.

This QA Inspector randomly observed ABF welder Donald Plumb #0891 perform SMAW on (2) two pipe stand base plates located at PP123-E2 and PP121-E2. Quality Control was present and the work had been conducted without approved details from Engineering. The plates had CCO266 written on them. This QA Inspector will generate a TL-15 on 06/23/2013.
